Analysis of the thermal behavior of historical box type windows for renovation concepts with CFD

Institute of Thermal Engineering:

Institute of Building and Construction:

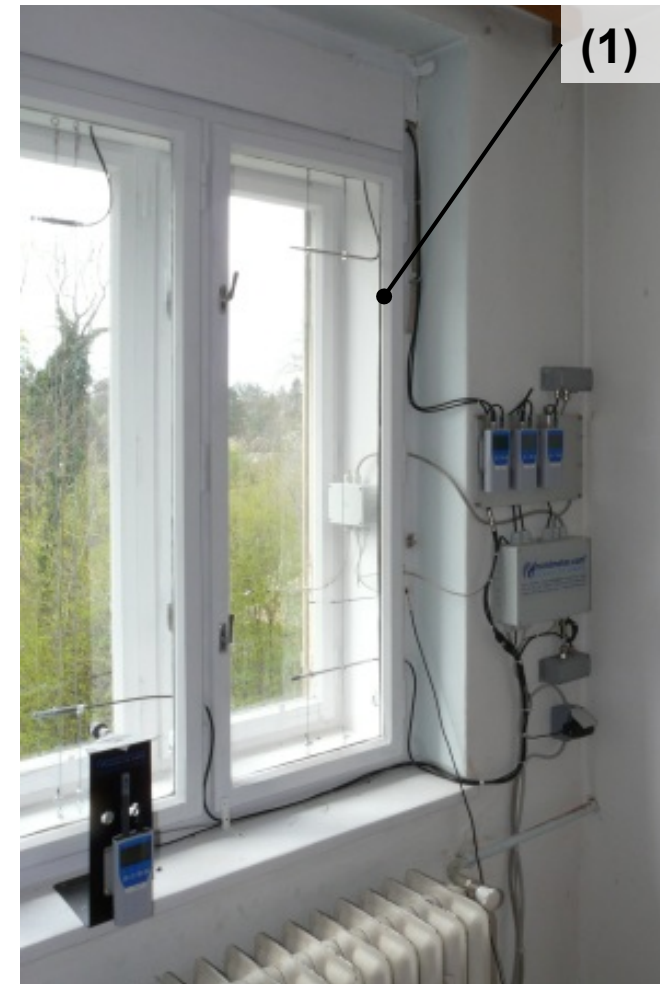
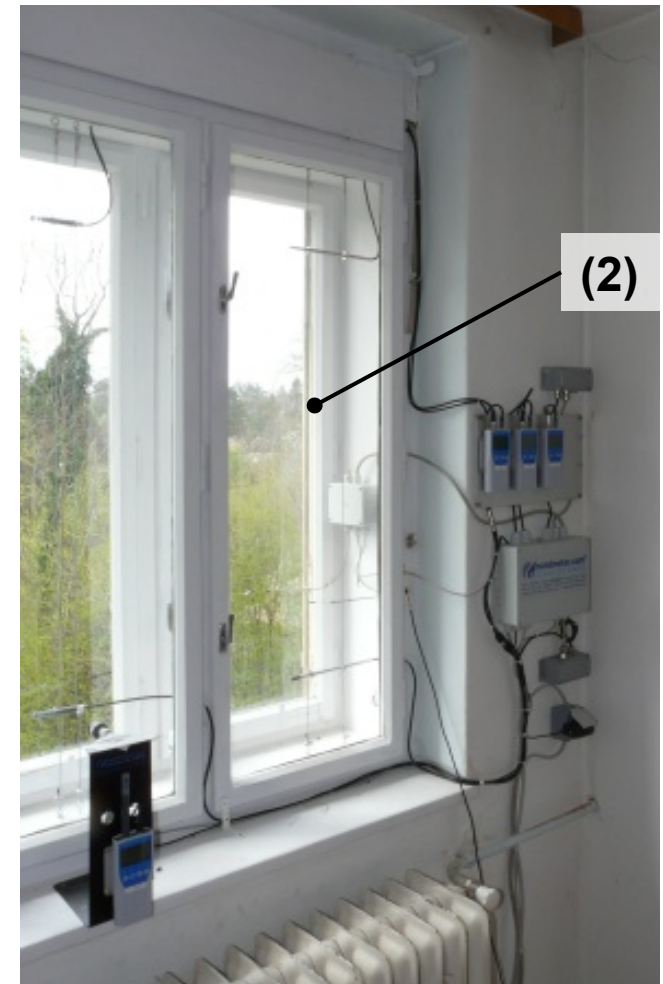
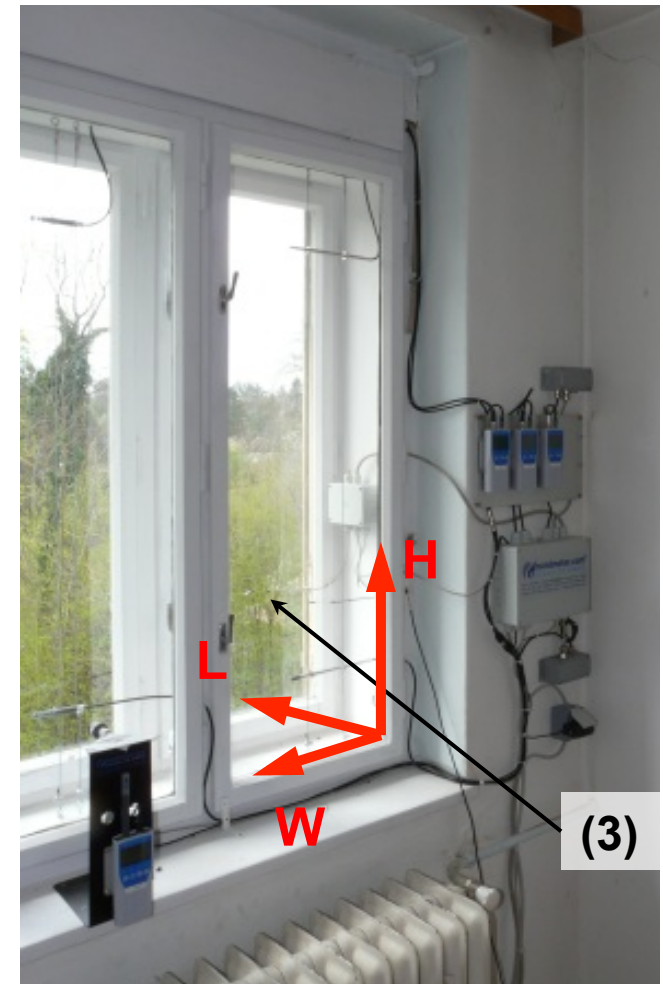
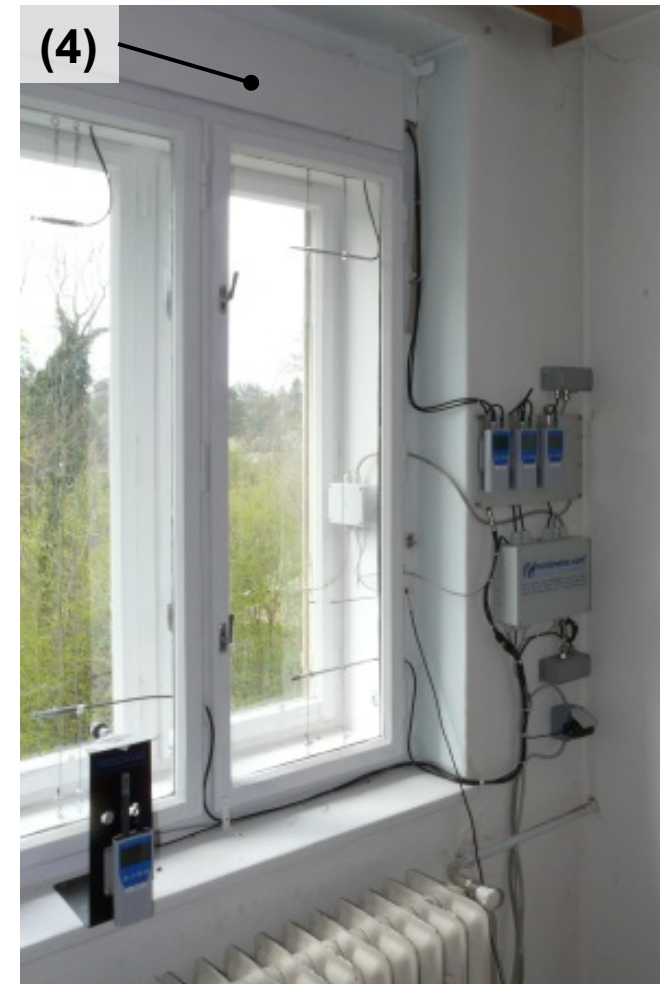
- Distance between casements about 150 and 200 [mm]
- Main dimensions are 1.63 x 1.76 x 0.28 [m] (W x H x L)

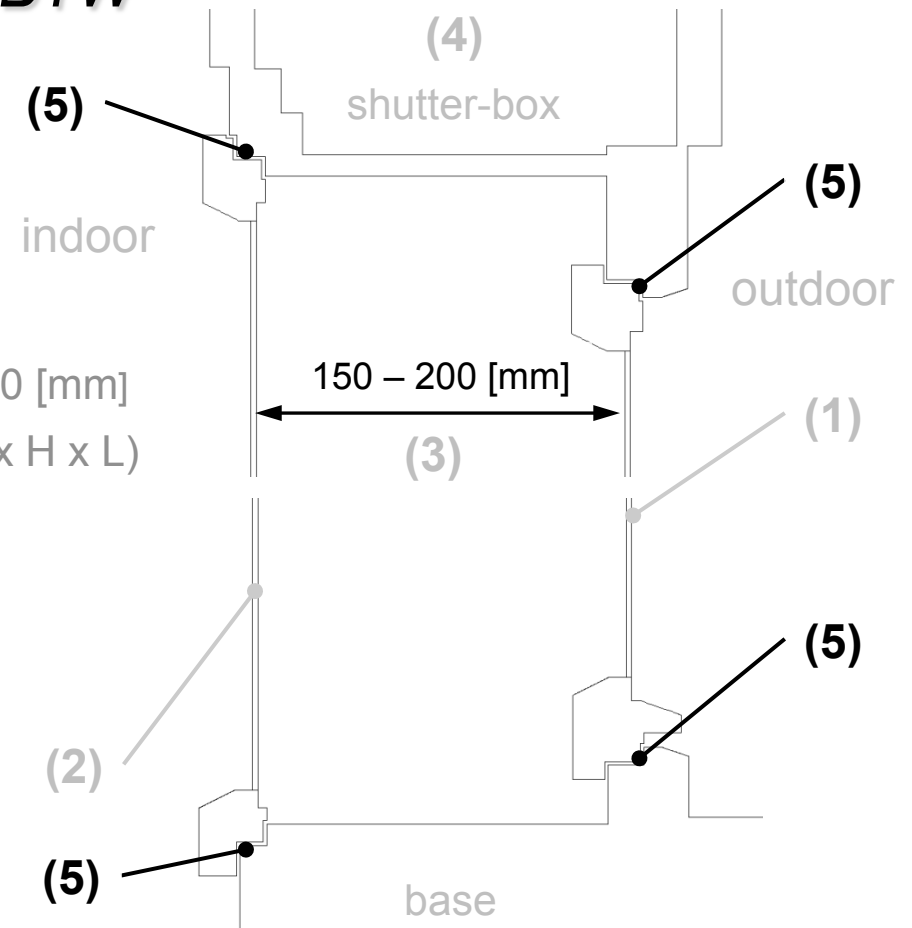
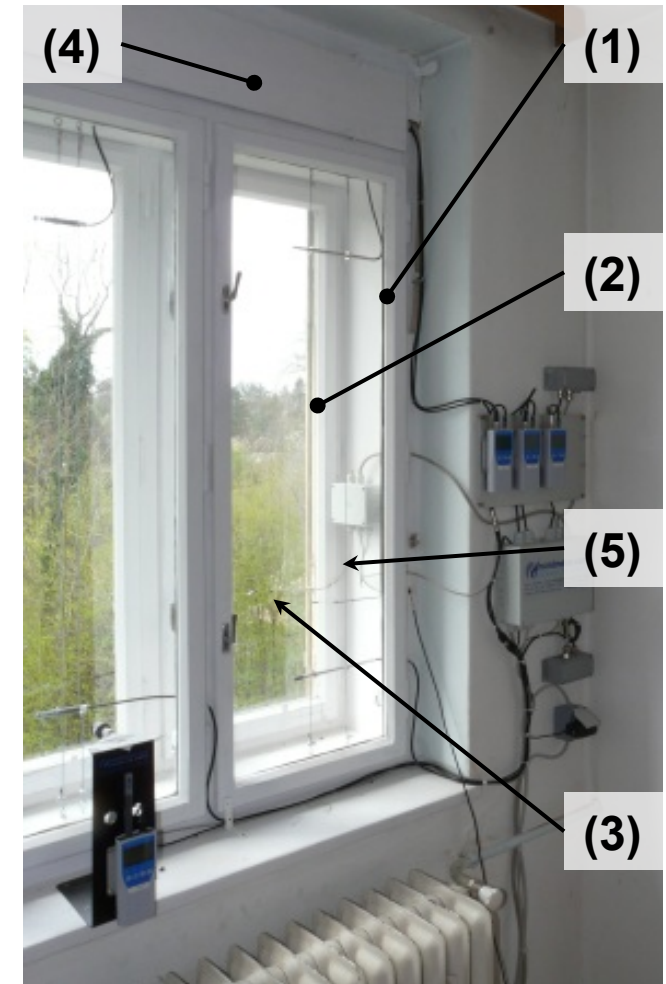
(5) Air permeable joints

- joint width about 0.5 to 5.0 [mm]

- Joints allow natural air change
- Prevents damage of wooden parts by moisture

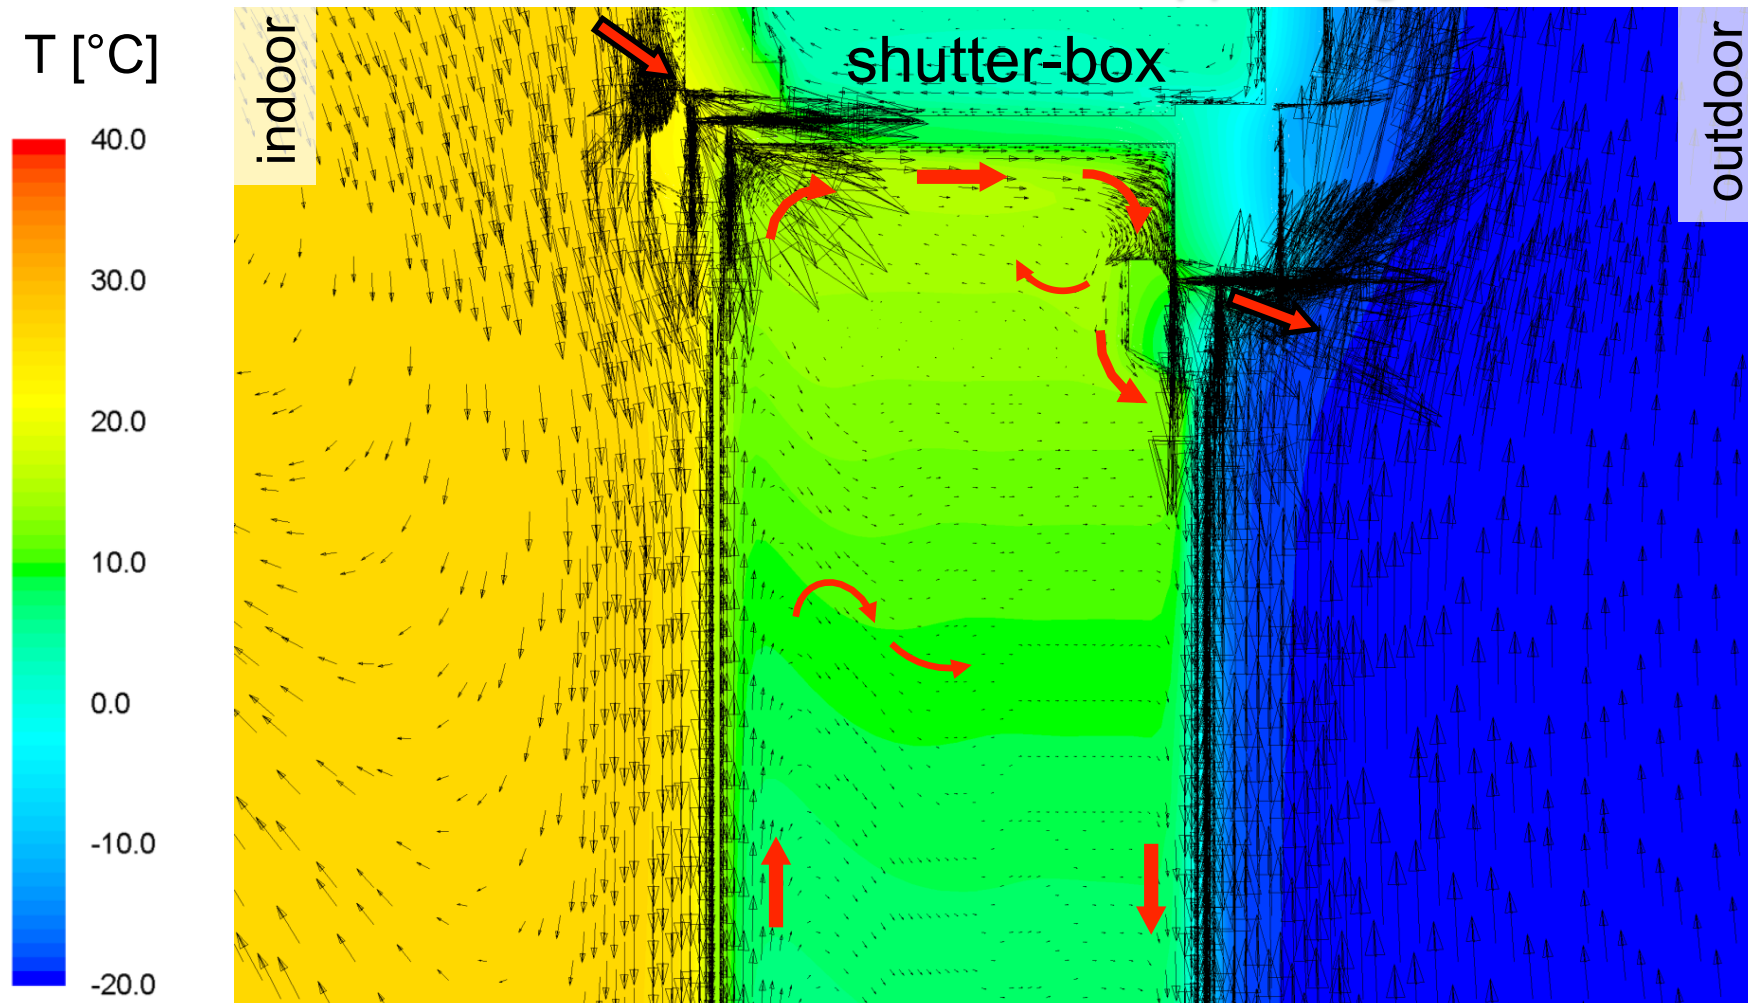
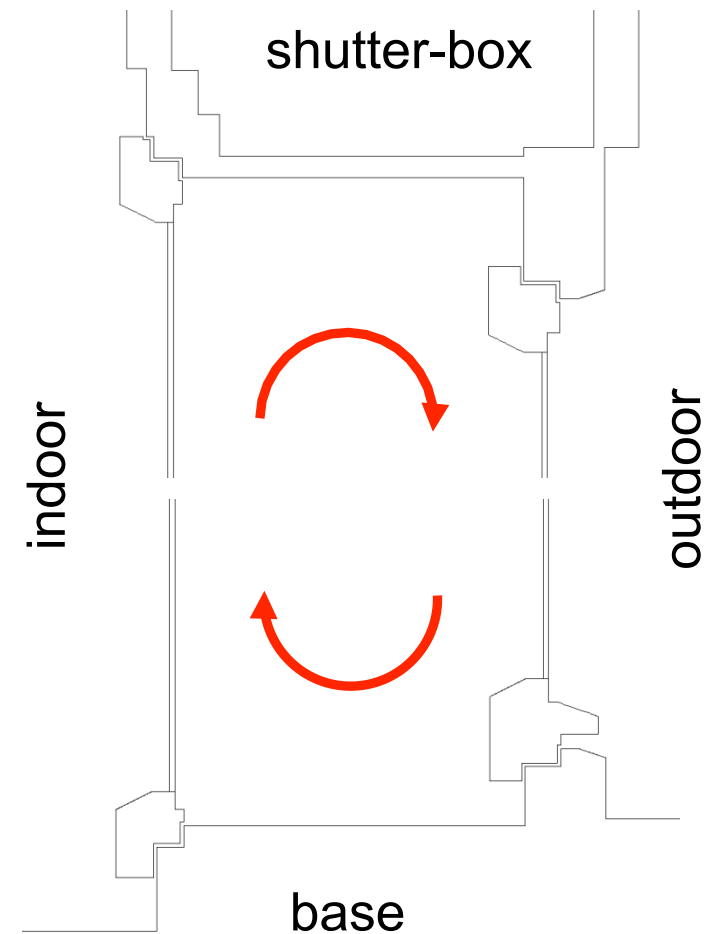
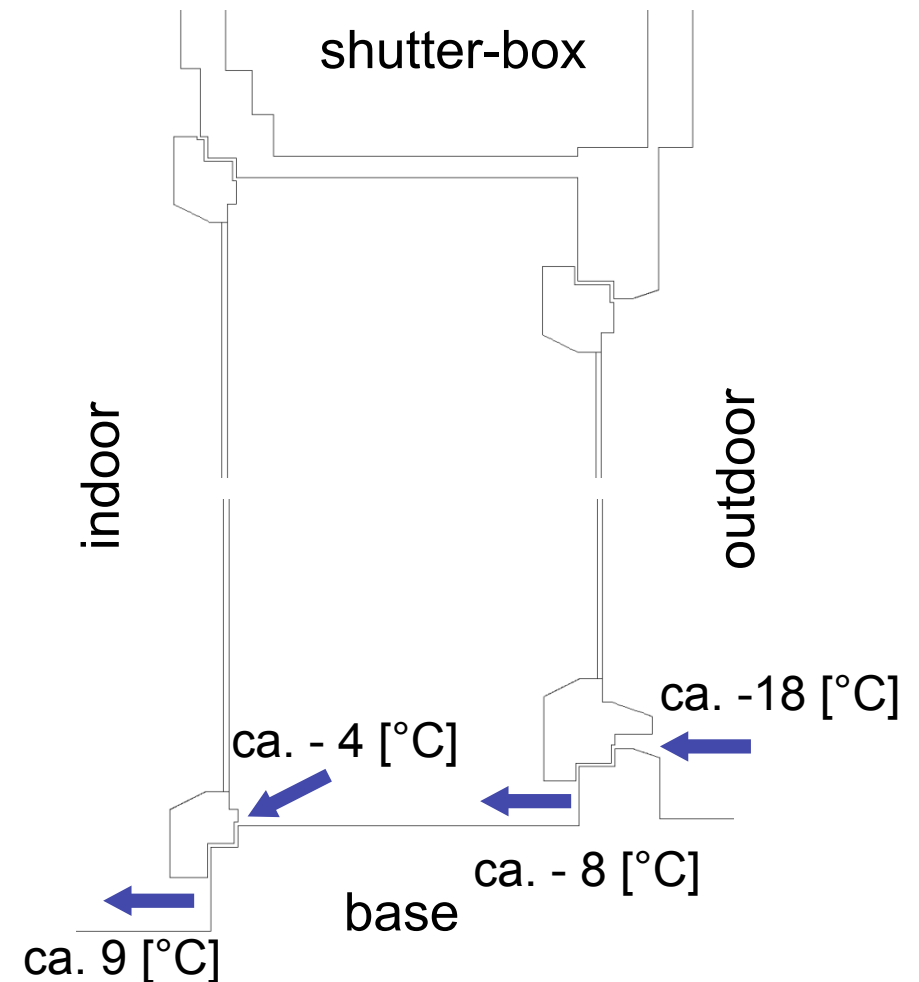
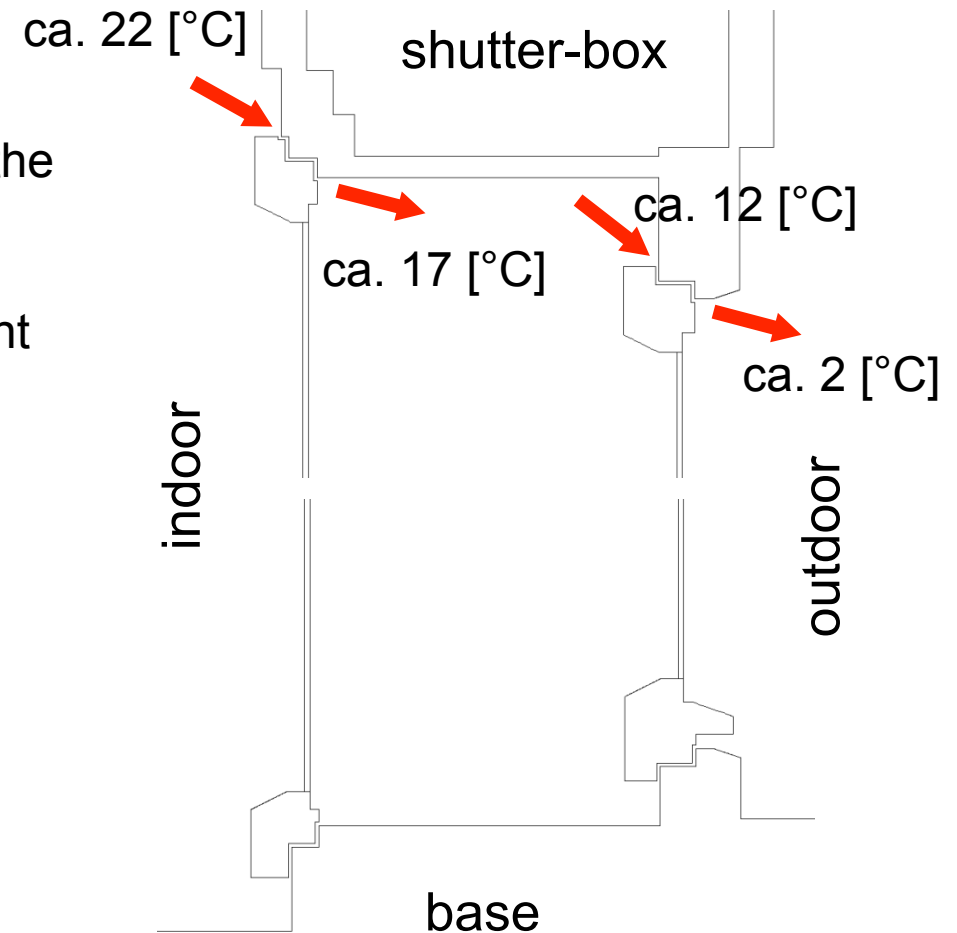
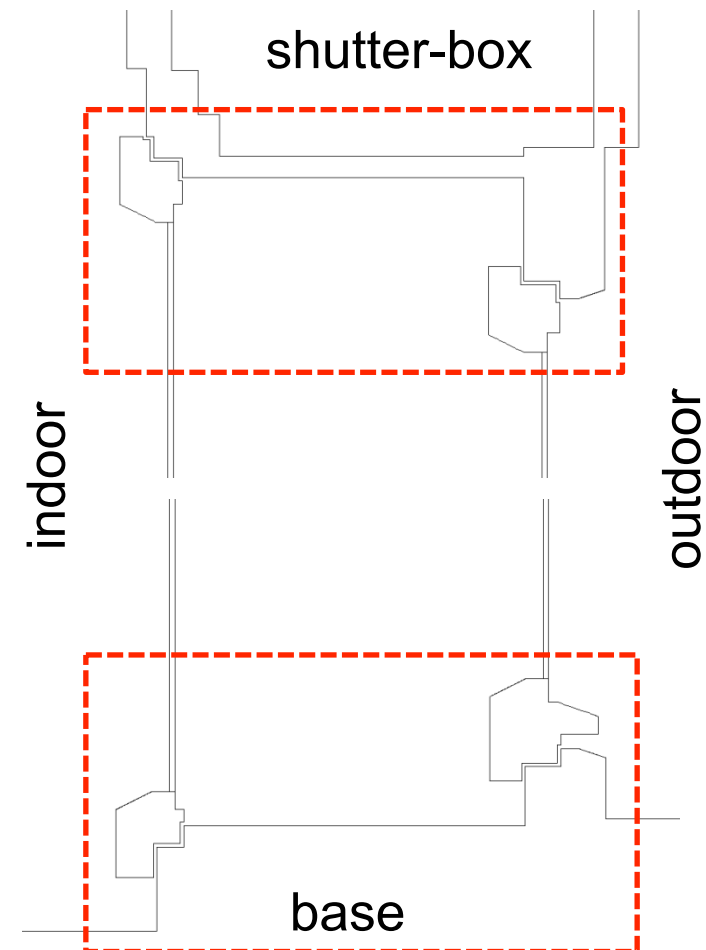
CFD – BTW refurbished – upper region

- Circulation of air inside the BTW cavity
- Cold air flows inside the cavity and also into the room
- Heated air got lost to the external environment
- Ventilation effects amplify the temperature stratification
- Turbulences occur in the region close to the air permeable joints

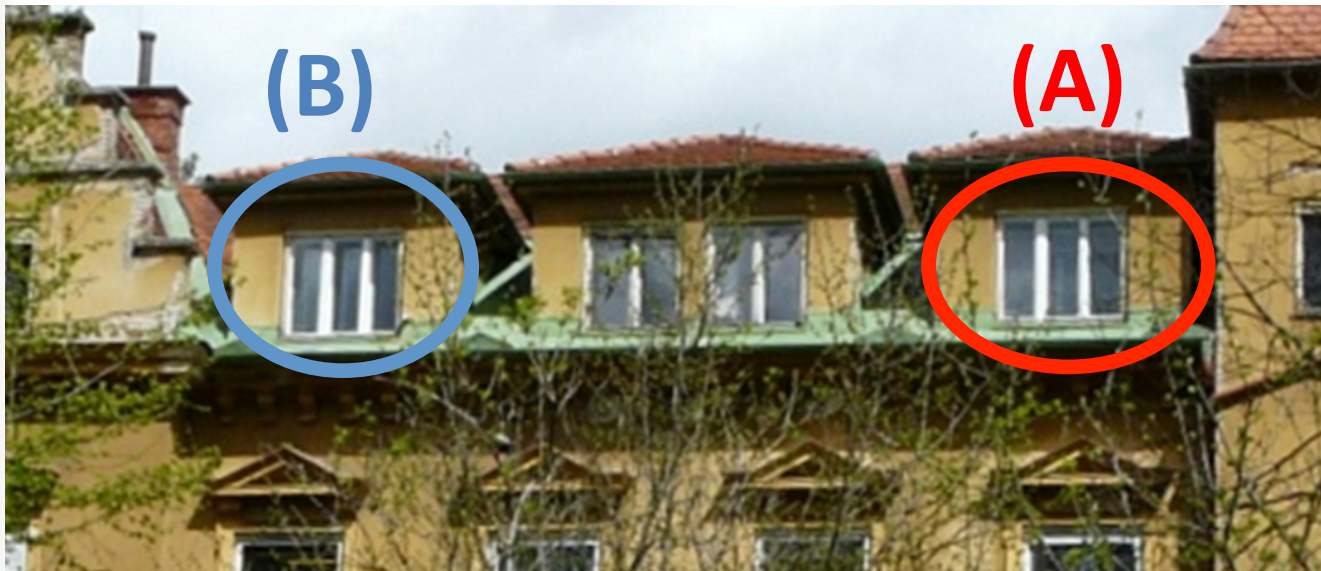
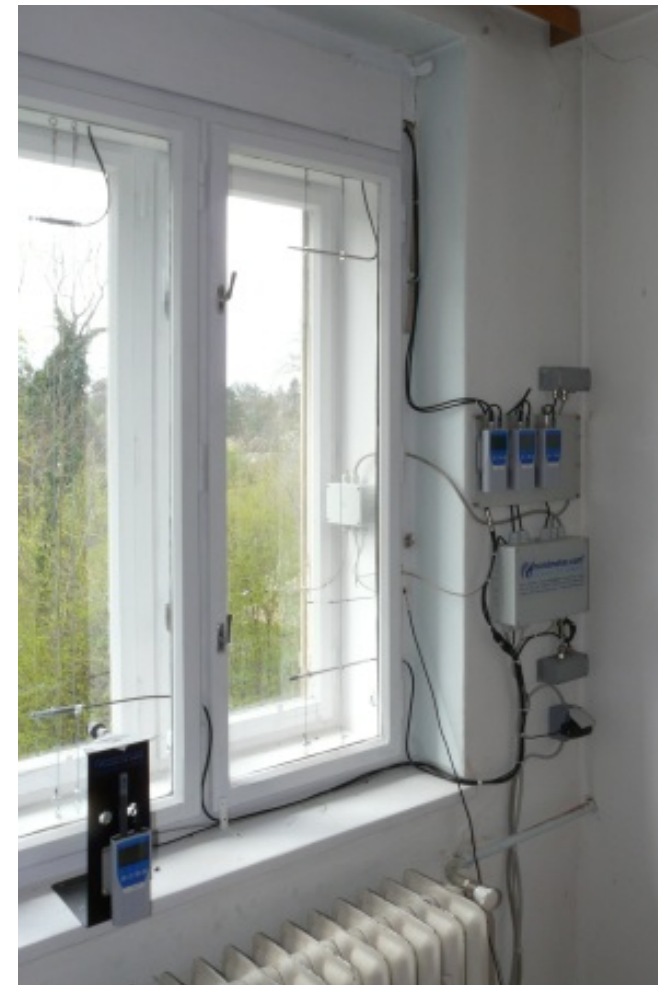
reference object of the research project “denkmalaktiv I”:
Schönbrunnngasse 30, 8034 Mariatrost in Graz, Austria,
a former mental home built in 1885, now a public kindergarten.

A.... BTW- refurbished B.... BTW-improved
(improvements: inner gasket frame, low-emission coating for
inner pane, thermal insulation for shutter-box)

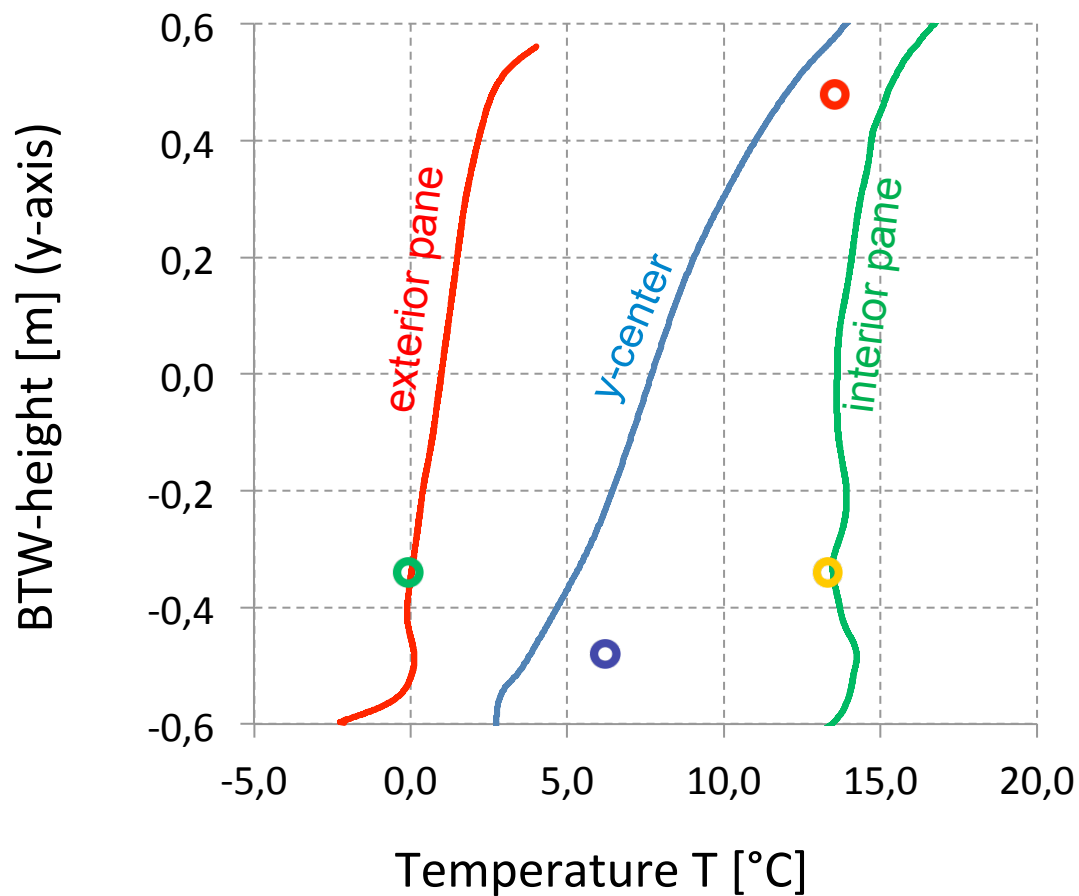
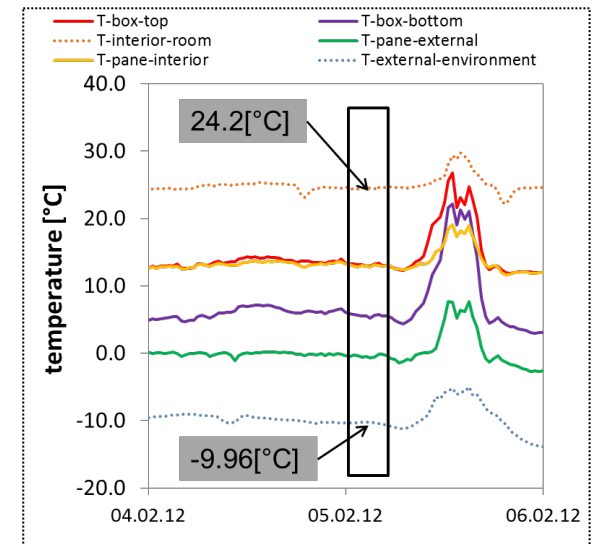
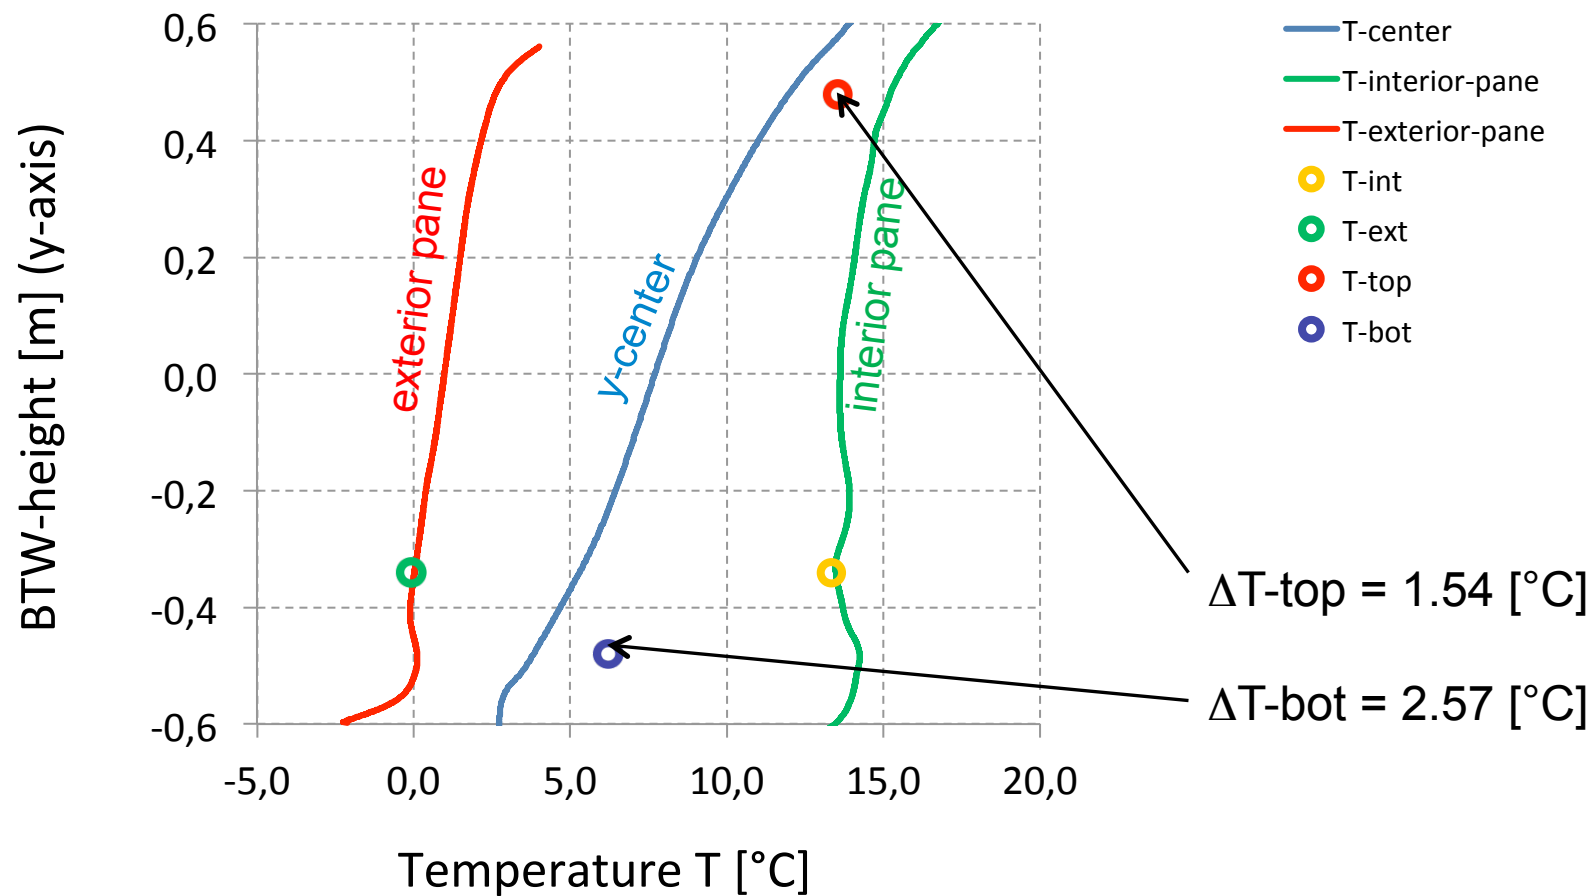
Comparison Measurement vs. Simulation

- T-center
- T-interior-pane
- T-exterior-pane
- T-int
- T-ext
- T-top
- T-bot

- Partly good agreement of computed and measured temperatures
 - Differences are explainable by the assumption of 2 [mm] gap width for the air permeable joints

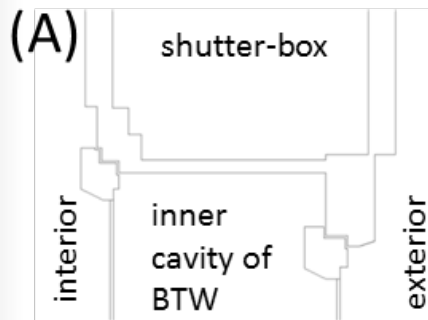
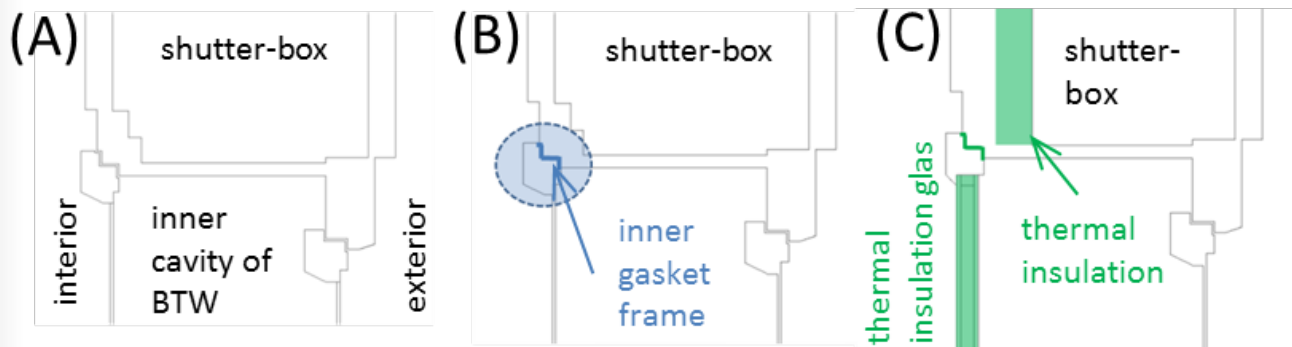
Renovation Concepts

A.... refurbished

B.... inner gasket frame

C.... insulated glass inner casement and thermal insulation for shutter-box

D.... additional interior casement

E.... vertical airproof divider

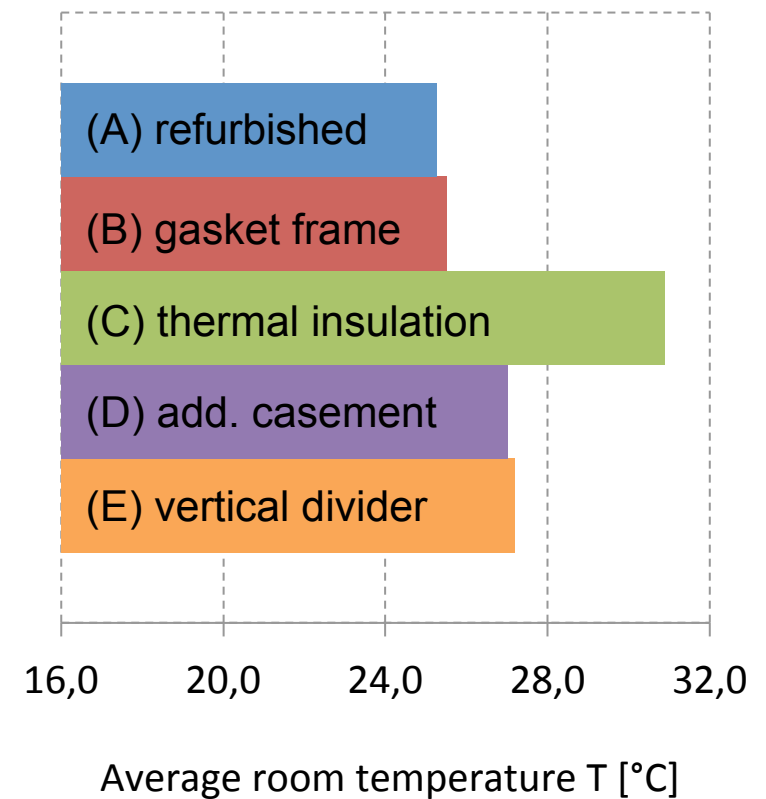
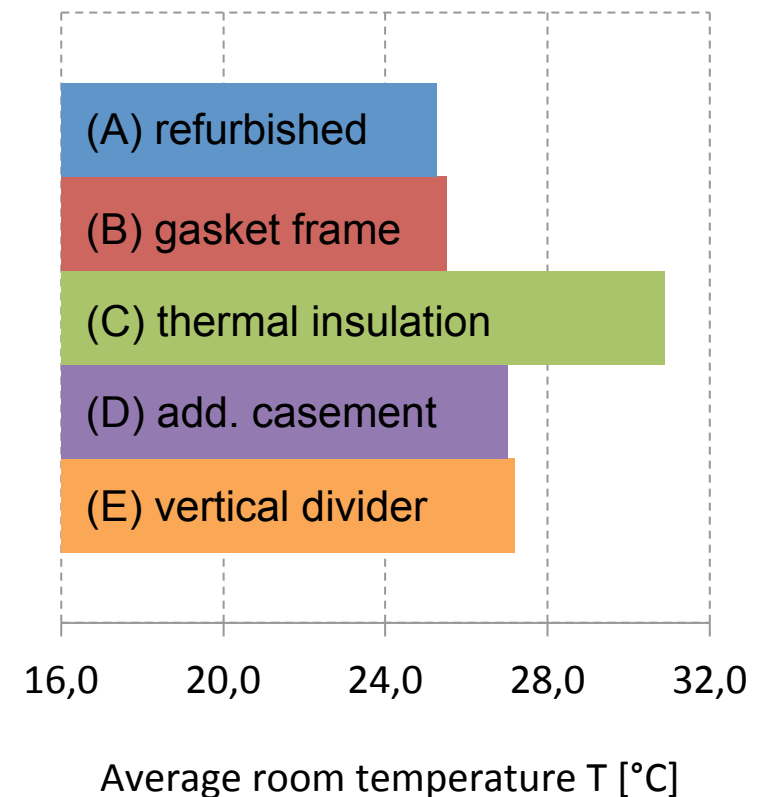
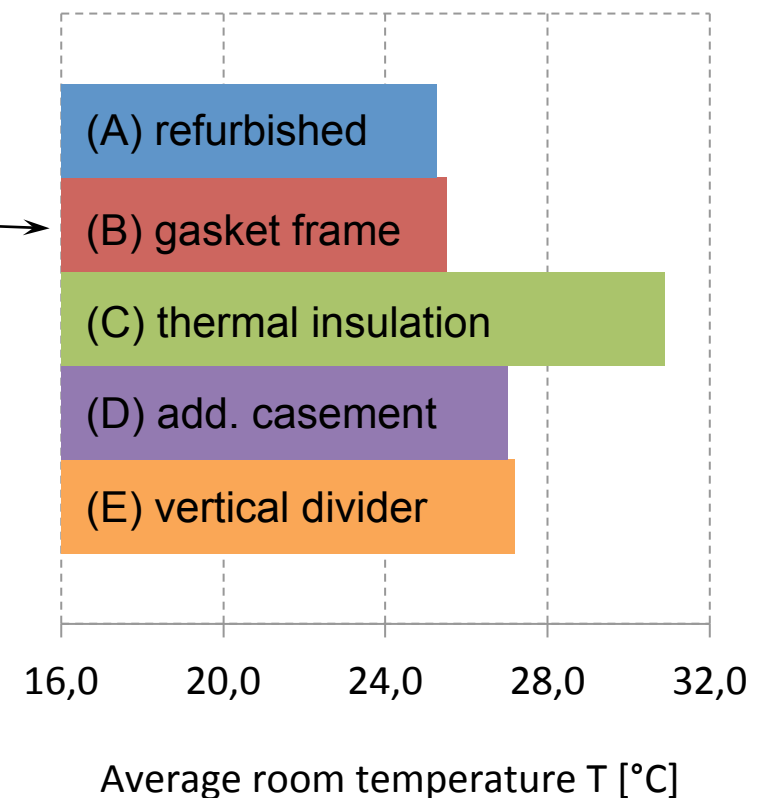
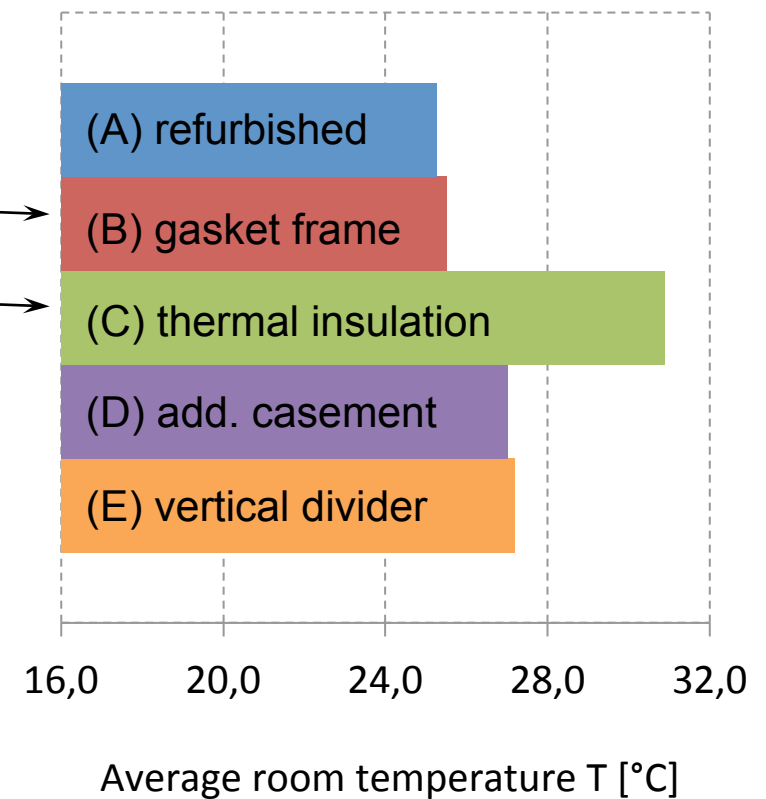
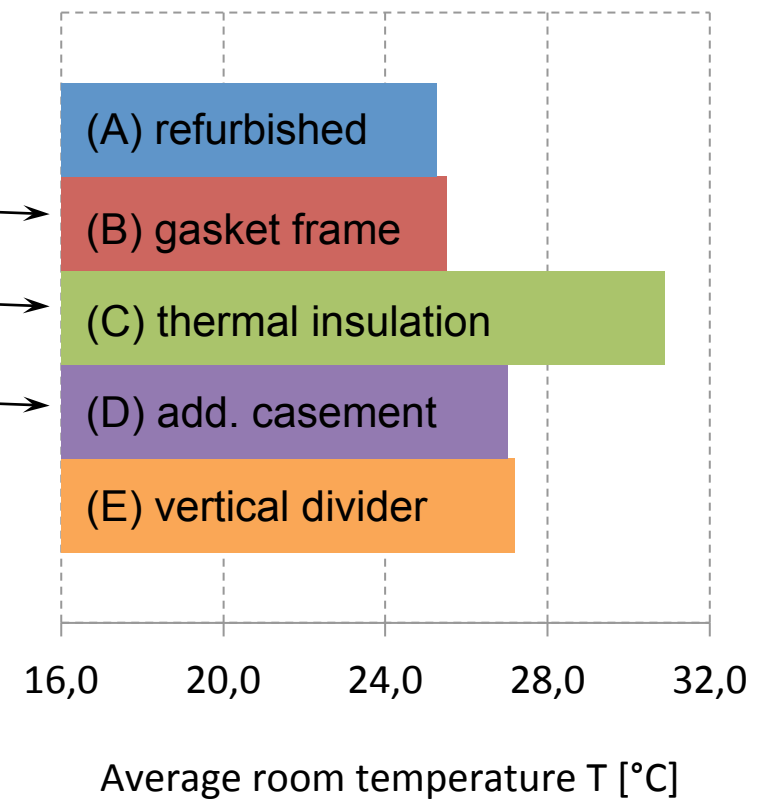
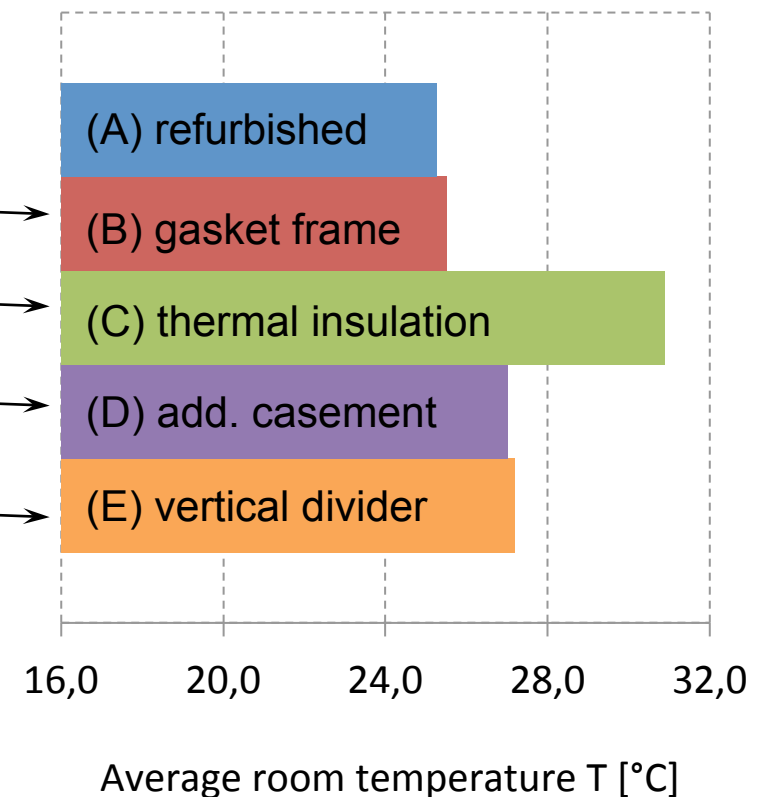
- Average room temperature $T_{\text{average,BTW(i)}}$
- Rating = difference of average room temperature compared with (A) refurbished BTW

$$\text{rating}_{BTW(B)} = 1.24\%$$

$$\text{rating}_{BTW(C)} = 21.6\%$$

$$\text{rating}_{BTW(D)} = 4.4\%$$

$$\text{rating}_{BTW(E)} = 6.9\%$$

- Average room temperature $T_{\text{average,BTW(i)}}$
- Rating = difference of average room temperature compared with (A) refurbished BTW
- U-value calculation
 - With CFD
 - Virtual test rig (2D-geometry)
 - Room temperature = 25 [°C]
 - External temperature = -20 [°C]

U-value [W/m ²]	BTW	Facade + BTW
(A) refurbished	1.73	1.38
(B) gasket frame	1.69	1.35
(C) thermal insulation	0.76	0.65
(D) add. casement	1.31	1.08
(E) Vertical divider	1.32	1.09
